REPAIRING OF DRY SPALLED AREAS

TYPICAL DETAIL

DWG: PDN027

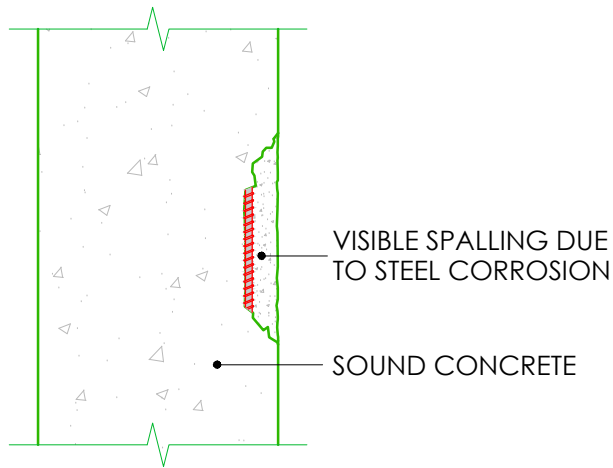
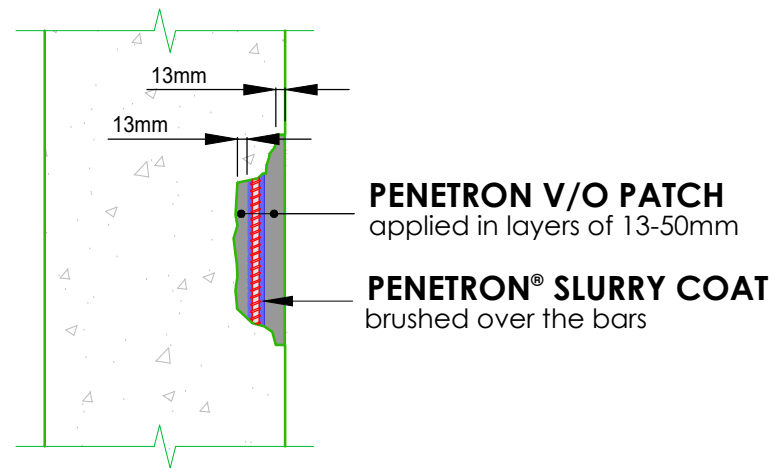
NOTE: JACK HAMMER THE AFFECTED AREA TO GET TO SOUND CONCRETE

PENETRON V/O PATCH
PENETRON COATING
