REPAIRING OF WET HONEYCOMBED OR CHIPPED AREAS

TYPICAL DETAIL

DWG: PDN024

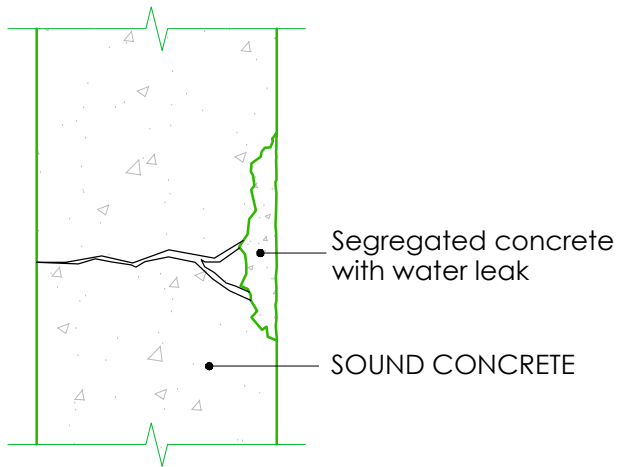
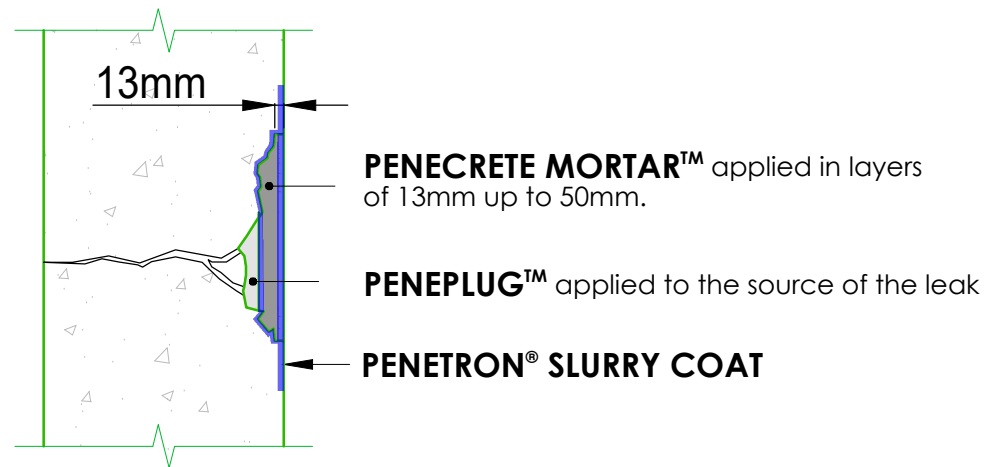
PENECRETE MORTAR
PENETRON COATING
PENEPLUG
