REPAIRING OF WET SPALLED AREAS

TYPICAL DETAIL

DWG: PDN028

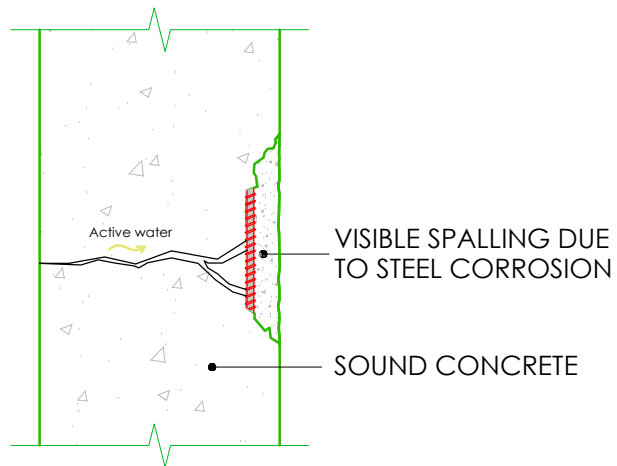
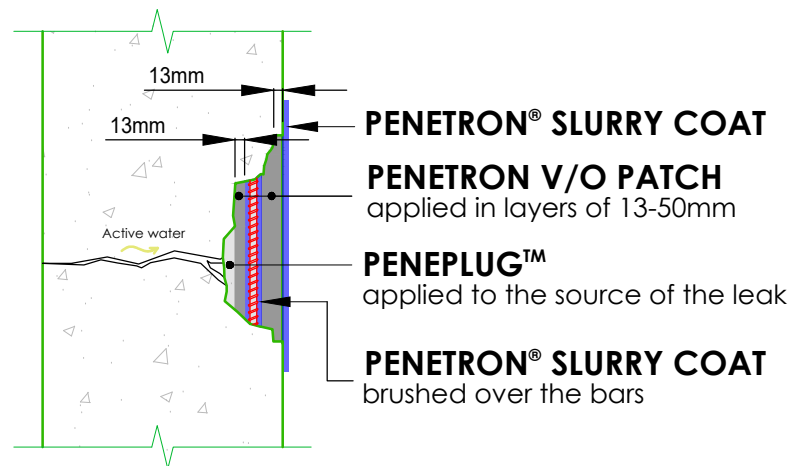
NOTE: JACK HAMMER THE AFFECTED AREA TO GET TO SOUND CONCRETE

PENETRON V/O PATCH
PENETRON COATING
PENEPLUG
